National Dam Inspection Program.
Ebenezer Dam (NDI Number PA-00599,
DER Number 38-8), Susquehanna River
Basin, Lebanon County, Pennsylvania.
Phase I Inspection Report.

**PHASE I REPORT
NATIONAL DAM INSPECTION PROGRAM
BRIEF ASSESSMENT OF GENERAL CONDITIONS
AND RECOMMENDATIONS**

Name of Dam: EBENEZER DAM, NDI NO. PA-00599
State & State No: PENNSYLVANIA, 38-8
County: LEBANON
Stream: CLARKS RUN, TRIBUTARY TO SWATARA CREEK
Date of Inspection: April 6, 1979

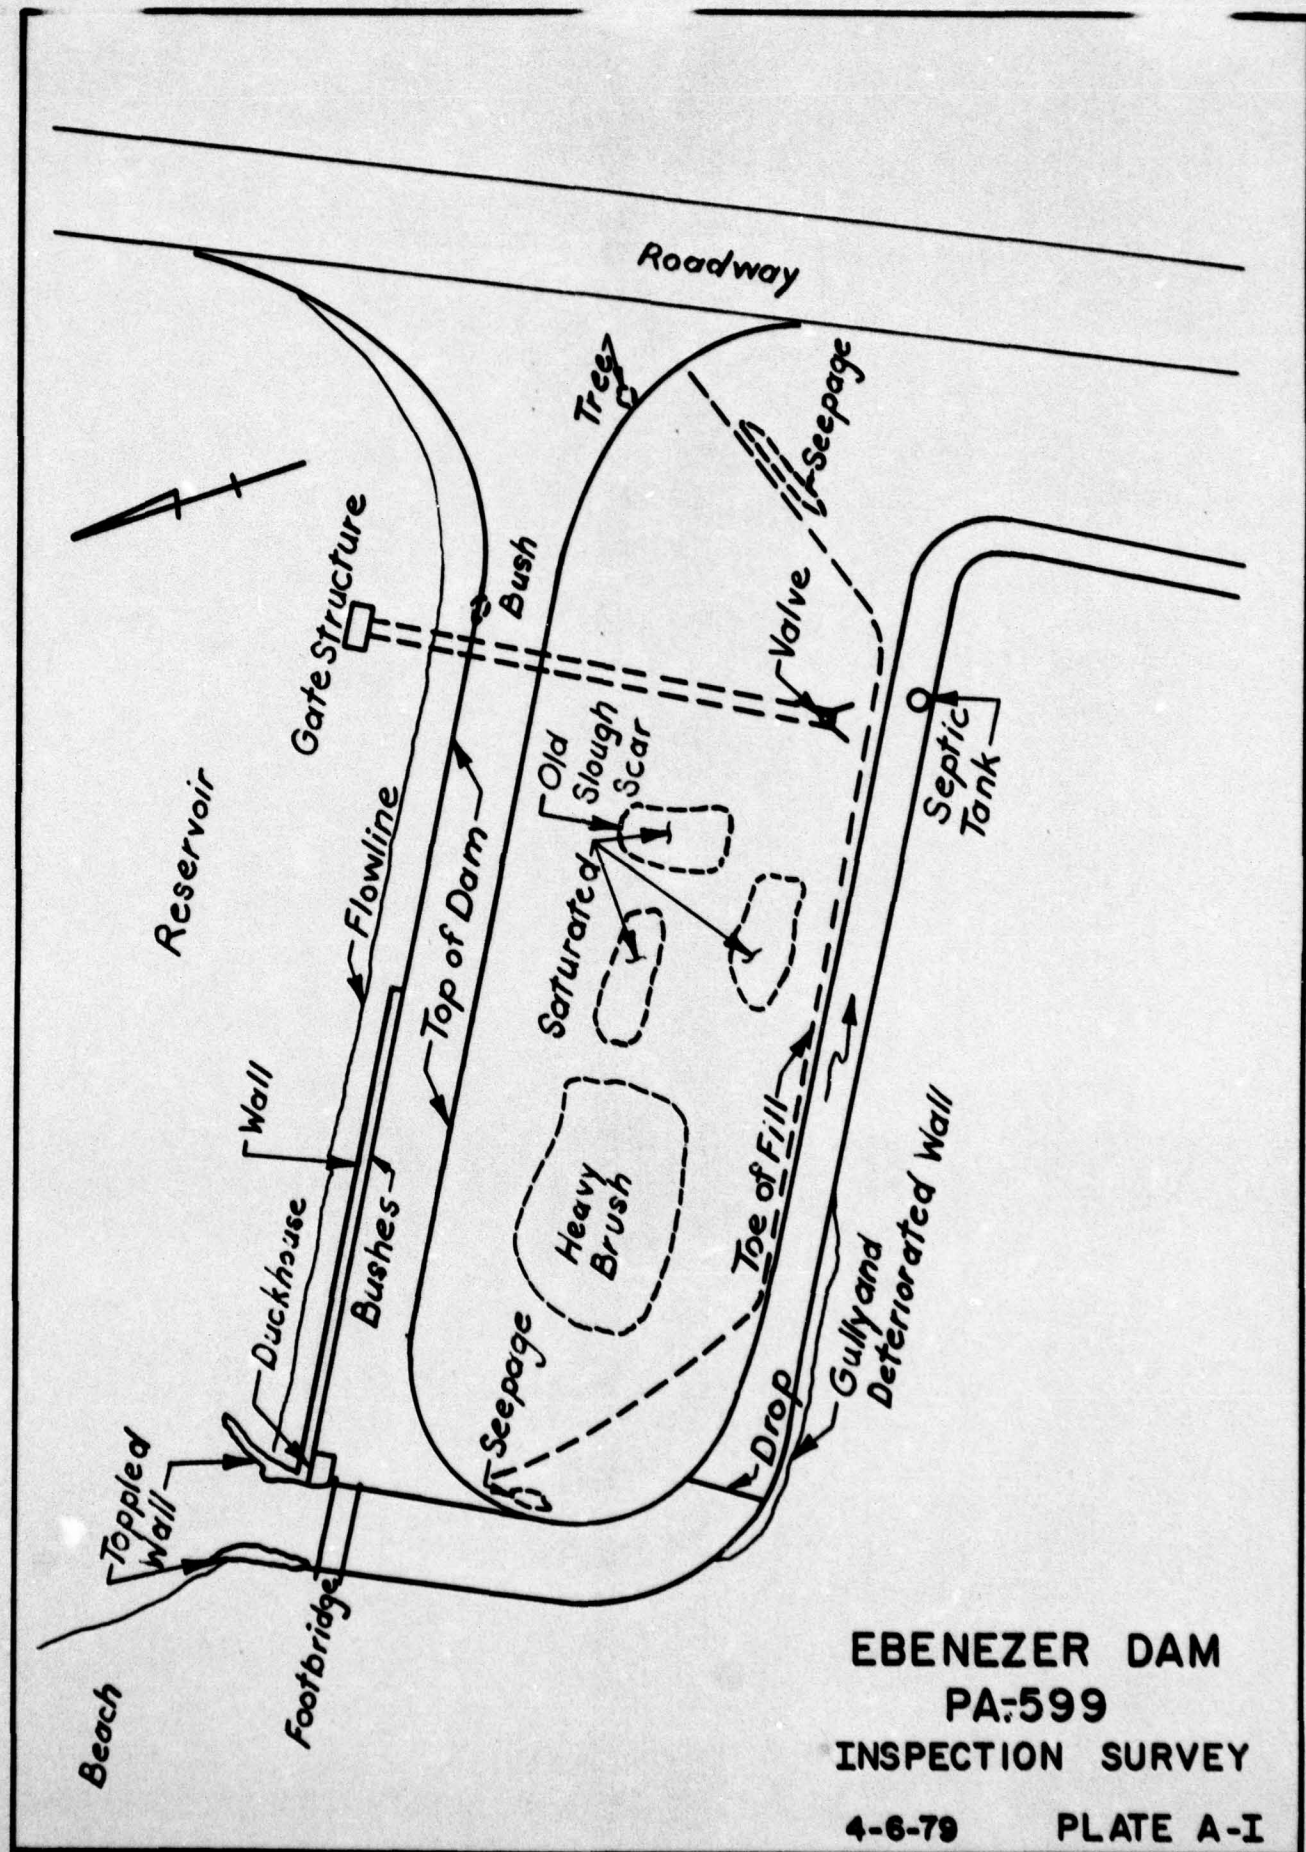
4-6-79 PLATE A-I

C. SLOUGHING OR EROSION OF EMBANKMENT OR ABUTMENT SLOPES	The downstream slope is not uniform. There is evidence of sloughage and movement of the surface along the length of the embankment. Also several groundhog holes were noted on the downstream slope. One slippage occurred (see Plate A-I and A-III).

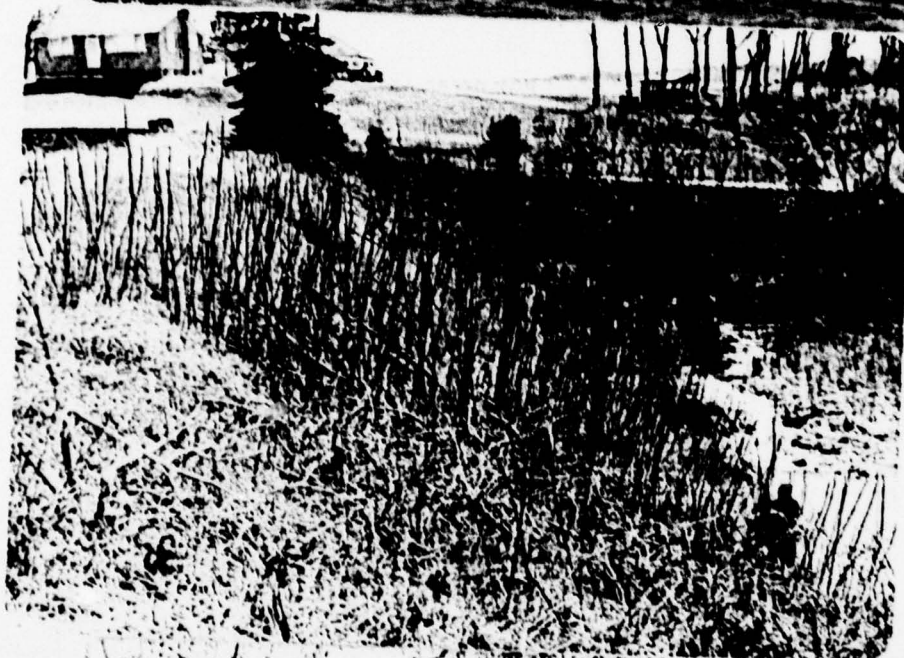
The downstream slope is in poor condition and has a large amount of weed, brush and sappling growth. Leakage through the embankment is evident along the entire slope. In several small areas the leakage is apparently limited to small horizontal layers within the embankment, showing no increase in seepage on the lower embankment face. In most cases, however, the "wet" zone shows marked increases in the water content in the lower limits of the embankment, becoming saturated at the toe, and immediately downstream. The saturated clay made a slippery surface to walk on and footprints would collect water. Undetermined amounts of leakage water were present at the left abutment and along the left spillway wall. The toe of the embankment is adjacent to the downstream discharge channel, preventing an evaluation of the amount of water seeping through the embankment.

Downstream Slope

1. Removal of all brush and trees from the downstream slope and establish procedures for regular maintenance of the embankment slopes and crest of dam.
2. Repair of downstream blowoff control valve.
3. Repair of the forebay walls and spillway chute.
4. Placing of riprap along the upstream slope.
5. Development of a formal surveillance and downstream warning system to be used during periods of heavy or prolonged precipitation.

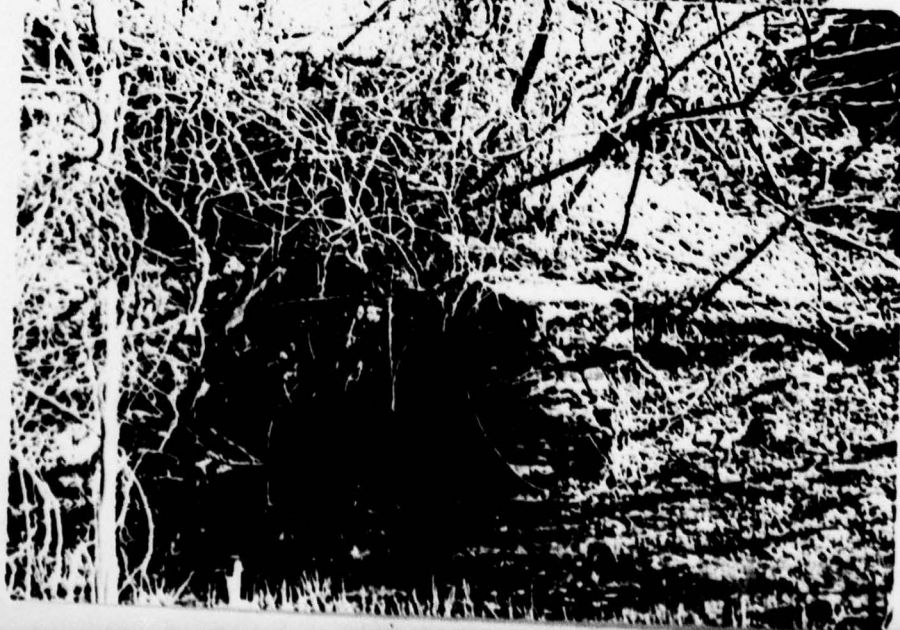
Conduit Outlet

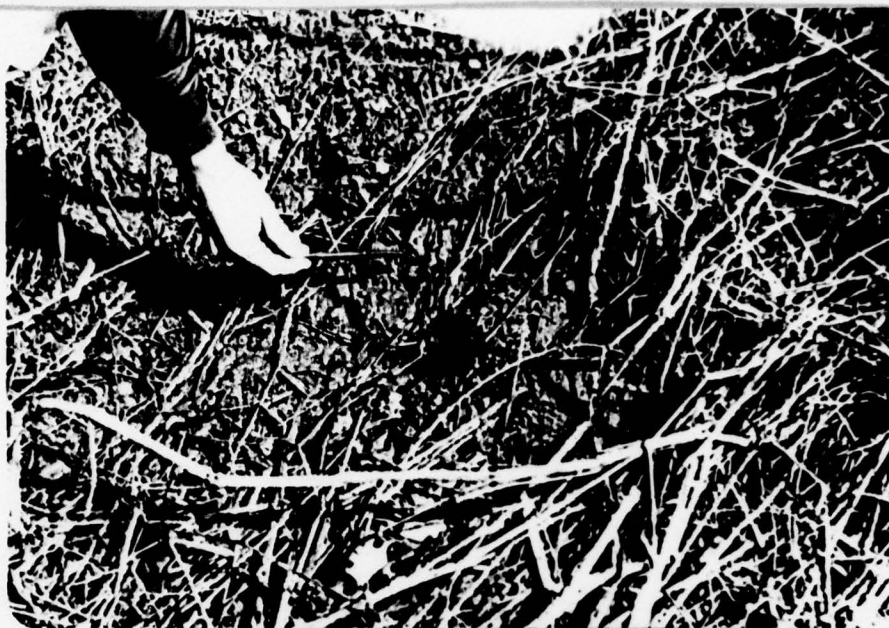
The visual inspection of the embankment indicates that serious problems exist on this 160 year old facility. The most serious condition is the saturation of the downstream slope. Although no flow of seepage water was detected except just to the left of the spillway, and at the left abutment, large areas of the downstream slope were very soft and slippery due to saturation. The brush, weeds and small trees made close observation of possible through-seepage difficult. The toe was wet at many places. The right hillside, beyond the spillway, also had several saturated areas. At the left abutment a steady seepage, estimated at 5 gallons per minute at the time of inspection, runs down the slope into the discharge channel. This water appeared to be clear. About 100 feet to the right of the left abutment a sloughage scar indicated that sloughage had occurred some time ago (see Appendix A, Plate A-I). The top of the dam is grassed. The upstream slope has a nearly vertical drop from the crest of the dam to just below flow line over the south half (left) of its length. The rest of the upstream slope has been protected from the flow line up by a masonry and brick wall (Refer to photographs, Appendix E).

Saturated
Downstream Slope

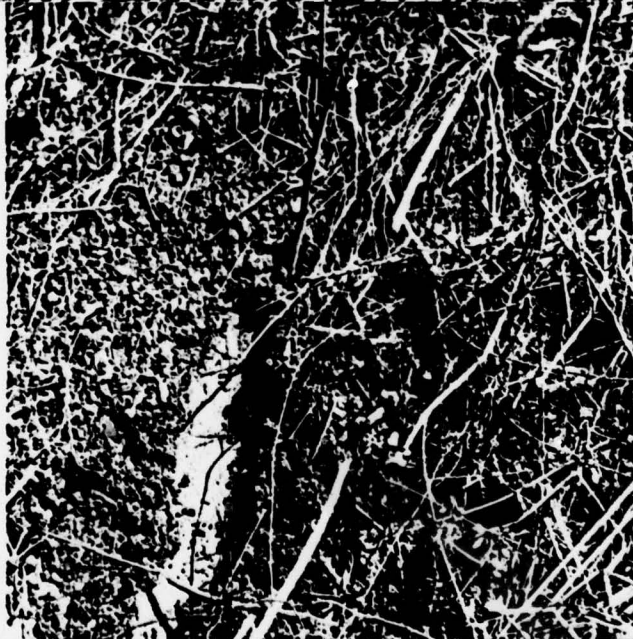
Downstream Toe

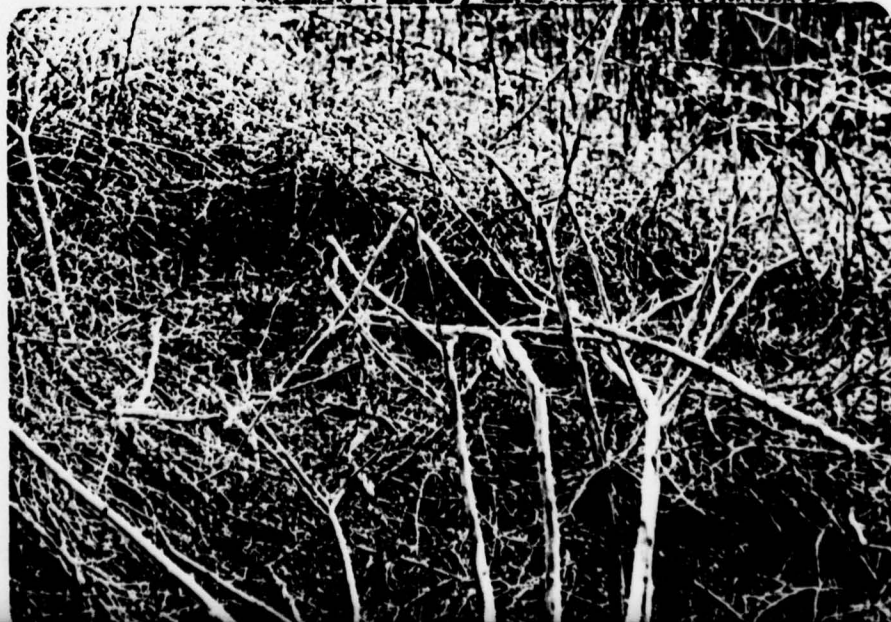
Slough on
Downstream Slope

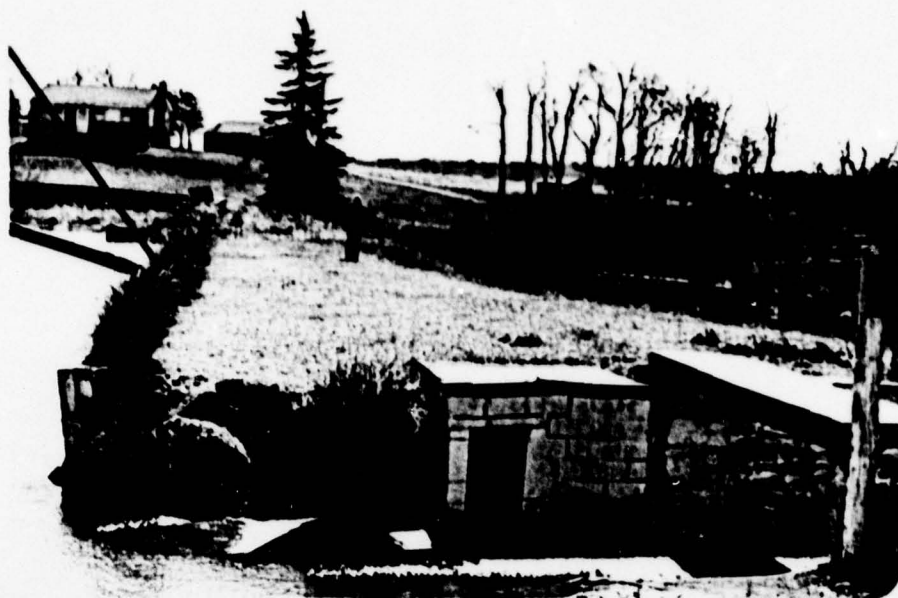
"Duck House" at
Spillway Bridge

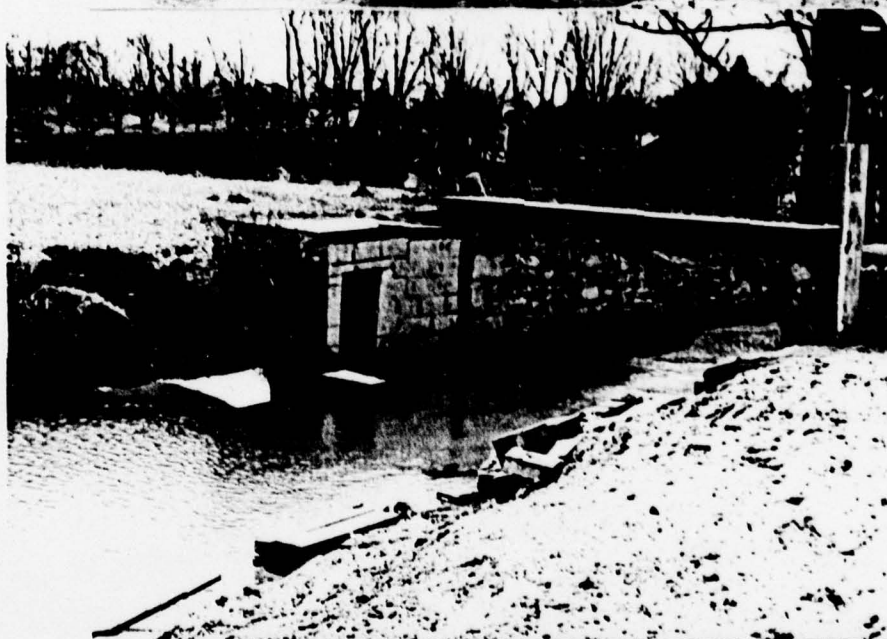
The broadcrested spillway is cut in original ground at the right abutment of the dam. The concrete block walls in the forebay area have fallen over into the approach opening (see photographs). The spillway channel is paved with concrete over the original flat stones. This channel makes a sharp bend to the left and then parallels the toe of the fill. The right wall of the chute, at this bend, is too low and has failed. Water flows over this wall and has caused considerable erosion in the soft shale behind the wall and failure of the wall over most of its length, beyond the bend.

Forebay

5. That the forebay and spillway chute walls be repaired.
6. That the upstream slope be protected with riprap.
7. That a formal surveillance and downstream warning system be developed by the owner to be used during periods of heavy or prolonged precipitation.

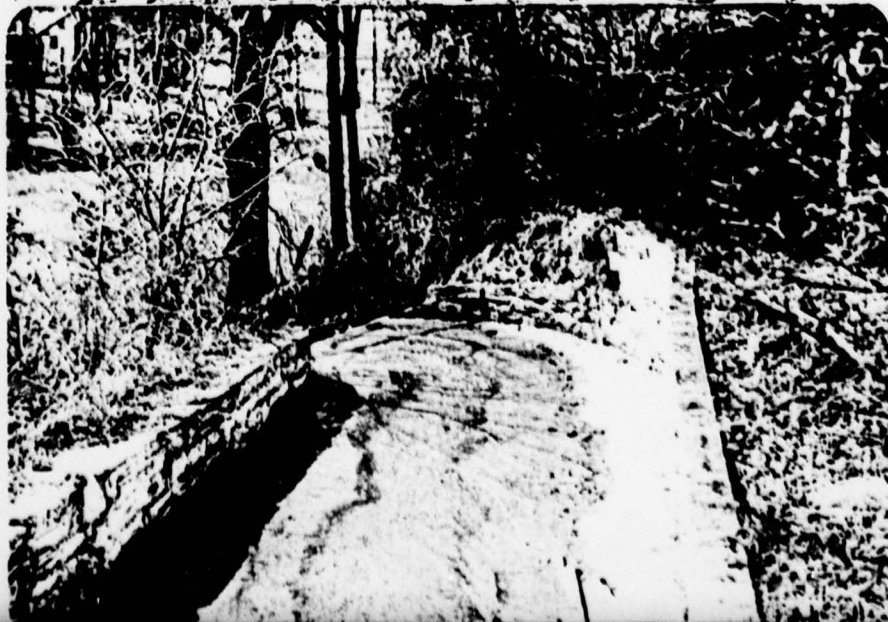
Top of Spillway
Chute

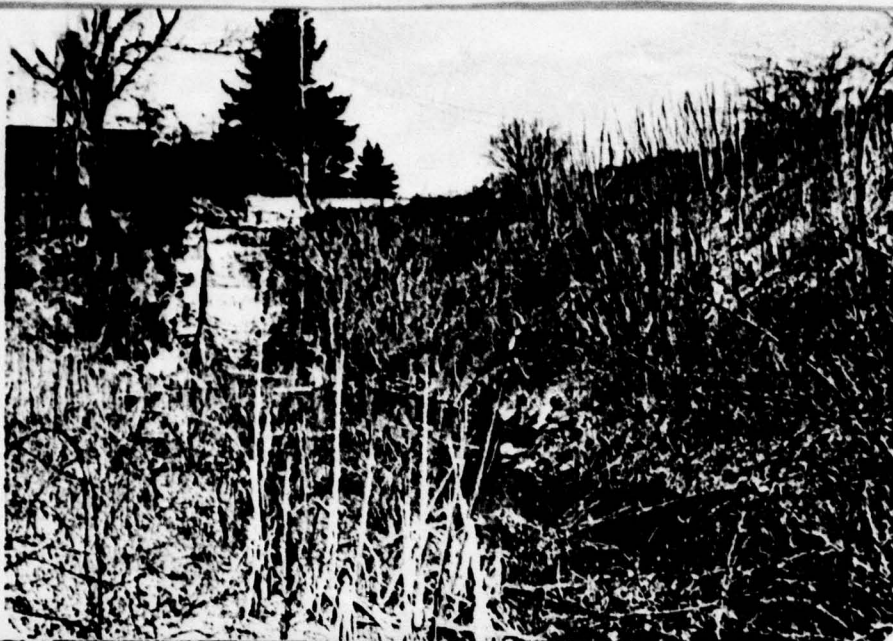
Spillway and
Downstream Channel

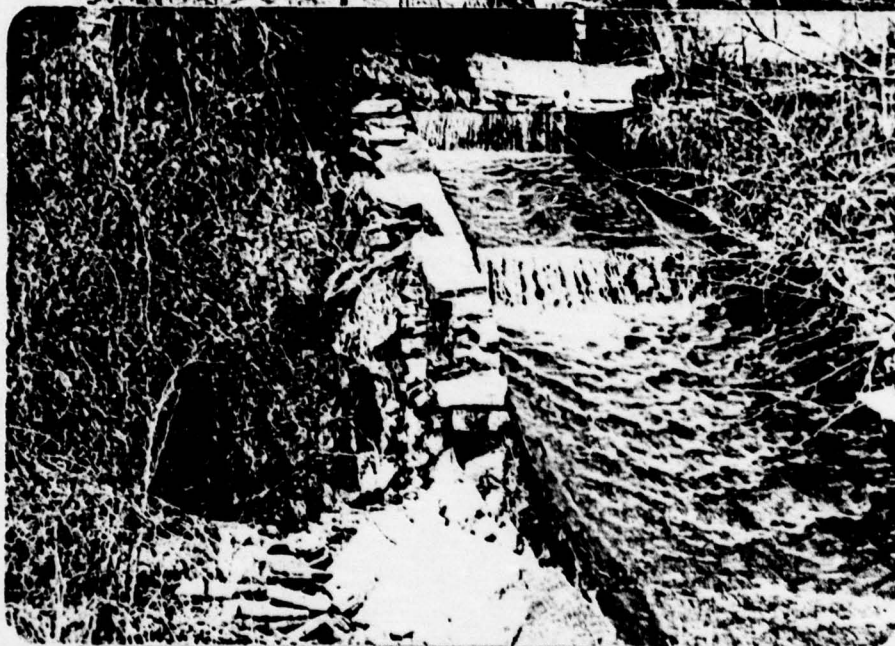
The walls along the forebay wall have fallen over, partially blocking the spillway entrance. The spillway weir and walls are in good condition. However, about 50 feet below the weir crest, at a point just below where the chute makes a sharp curve to the left, the right spillway wall was severely damaged during the tropical storm Agnes. If water flows more than a few inches deep over the spillway crest, some of the discharge runs over this low wall thus causing erosion behind the chute wall. No deep erosion has occurred because of the underlying rock, but the right chute wall has practically disappeared.

Deteriorated Right
Spillway Wall

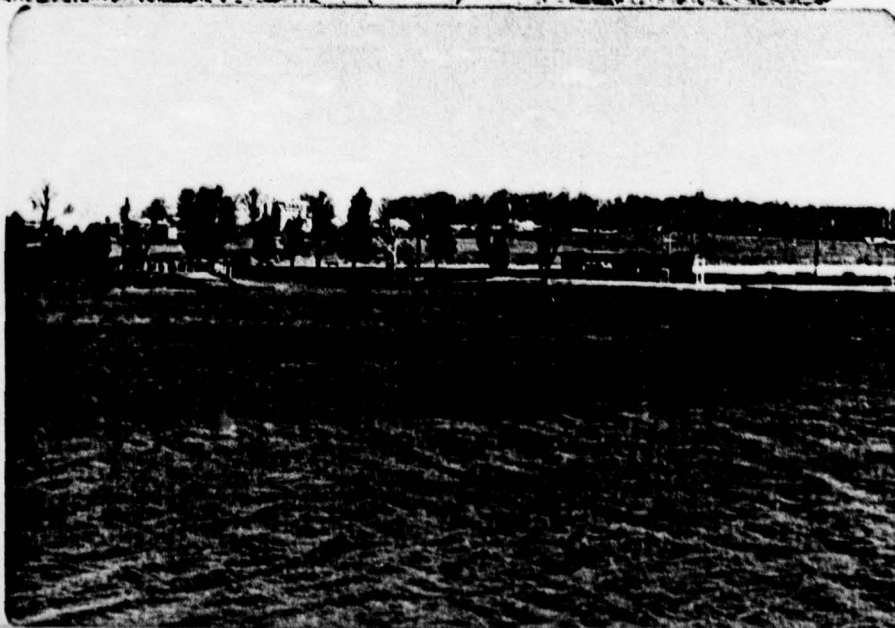
Reservoir With
Public Beach House
